Cause and Combat of Agriculture Land Desertification in Egypt Related to River Processes

Karima Attia and Yasser Raslan

Head of River Management and Modelling Department,
Deputy Director Nile Research Institute, Cairo, Egypt

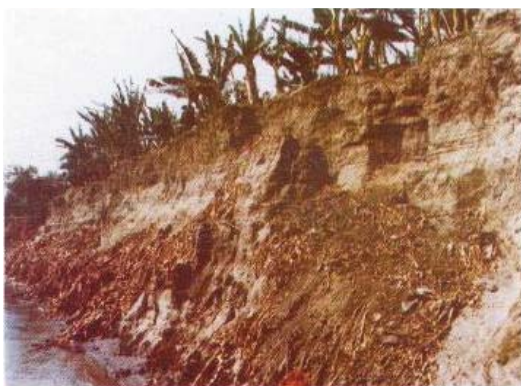
Photo 1: Composite land failure as a result of toe material removes (hydraulic factors)

The main forces that erode soil material were hydraulic forces (see photo 1 and Figure 3), geotechnical instabilities and a combination of both. The flow adjacent to the agriculture land exerts a stress that exceeds the critical shear stress for soil erosion and therefore the movement of the particles is initiated. Fluctuation of river water resulted in pore water pressure increase in the soil mass during the falling time and this increases

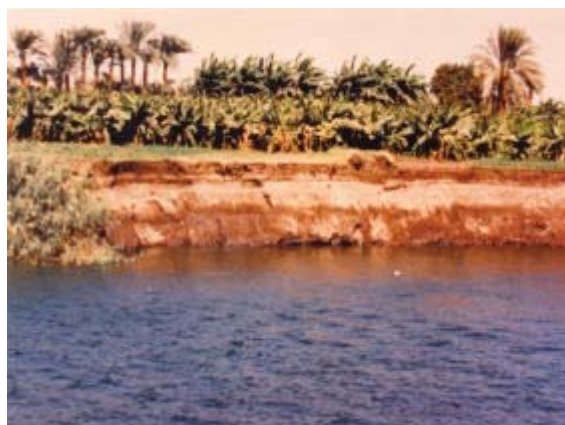
Photo 2: land erosion due to seepage effect

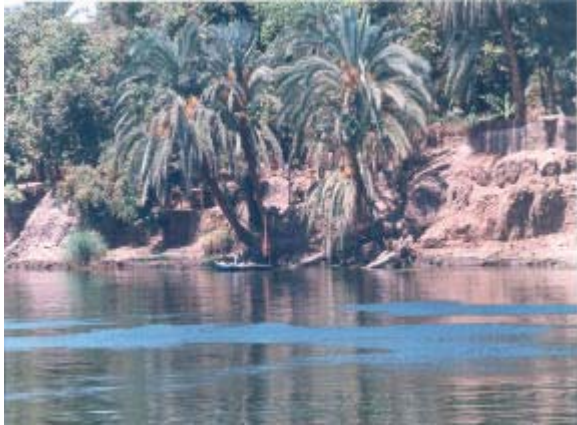
Photo 3: Steady progressive soil erosion reveals the root of palms

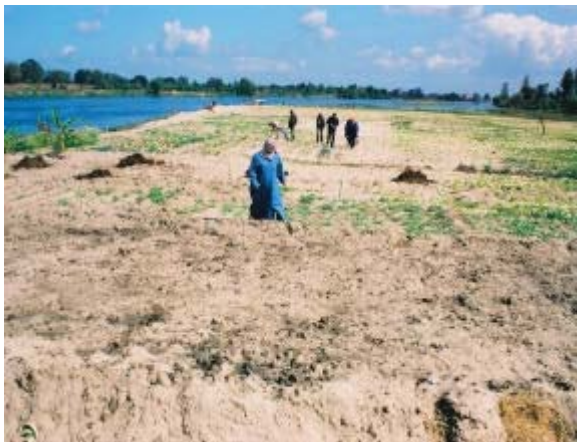
Photo 4: Low land heightened by dredged material in Damietta branch

by farmers to heighten their agriculture land to avoid inundation during high stage of the river. The farmers are unaware that these materials may have great potential of contaminants. Their concern is only concentrated that these materials will enable them to cultivate their land the entire year. Samples of dredged material (photo 4) are collected from 10 locations along Damietta branch, March 2008 to assess the extent of heavy metals in the soil due to dredged materials. The analysis indicates that soil type is sand which means light texture with high permeability. The PH values for the row dredged materials vary from 7.53 and 8.58 which indicate that the soil is neutral with the tendency of alkaline in one location. This problem can be combated by using organic fertilizer to produce CO₂ to decrease the PH value to the range 7-8.2. This will avoid occurrence of alkalinity problems which will lead to decrease the soil permeability. It will also prevent or decrease the solubility of heavy metals and subsequently avoid their risk. The use of O.M is important to increase the soil fertility which is negatively affected due to the continuous cultivation. The electrical conductivity (EC) values are coinciding with the value of the non-saline soils which are ranged between 0-2 ds/m except for one location.

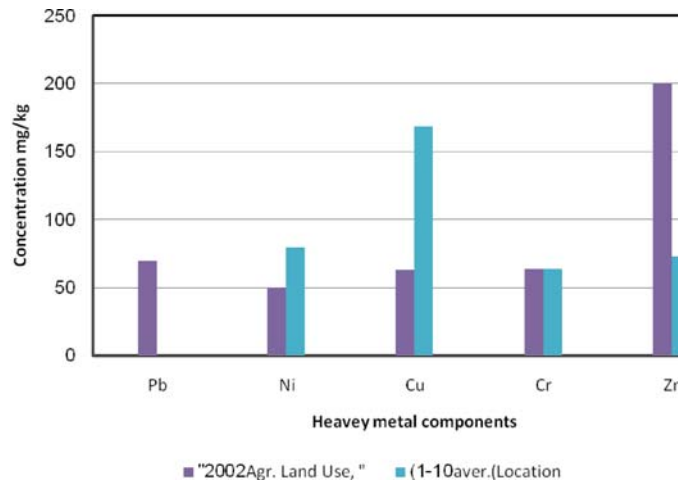
Fig. 4: Comparison of heavy metal content in bed material in Damietta branch to Canadian Agr. Land Use standard, 2002

Table 1 indicates the content of heavy metal in the collected samples. The average of the samples is compared to permissible values of agriculture land use, 2002 (see Figure 4). The figure indicates that the samples are suffering from heavy metal contamination however; the analysis indicates total content of heavy metal which includes soluble and precipitated forms. As the PH values of the soil are neutral to alkaline, which indicate that all the heavy metals are in insoluble forms. The problems of those metals may be appeared in case of decreasing PH value to the acidity range. As a factor of safety those soils can be cultivated by wood trees, palm dates, fruits without any environmental impact. Vegetables eaten fresh may not be cultivated in such soils.

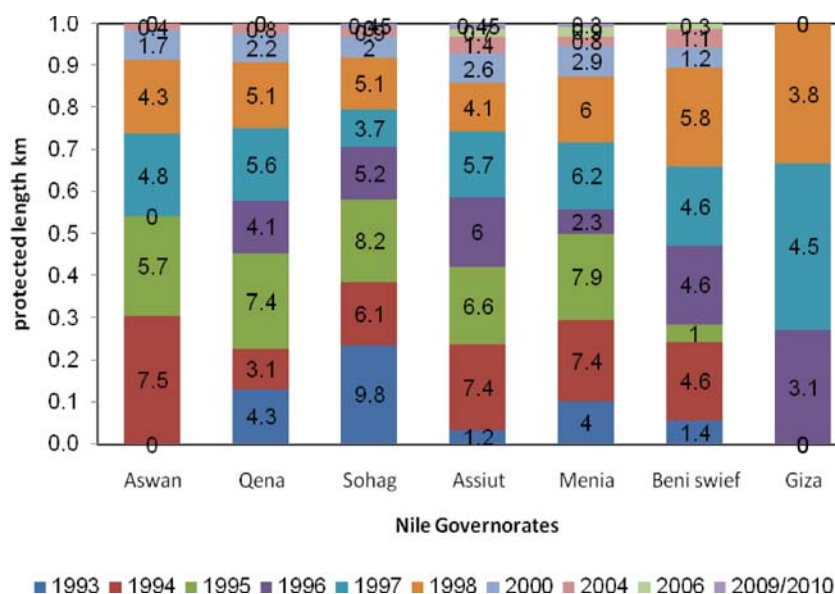
Fig. 8: Protection lengths distributed to Nile directorates

A number of projects for soil protection works were implemented during the period between 1993 and 2010. Figure 8 indicates a protected length of about 208 km distributed to different Nile directorates.
